SUPPLEMENTAL REPORT ON HURRICANE OF SEPTEMBER 21, 1938,
AND ITS EFFECTS ON THE COASTAL REGION.

2. Purpose. - This report supplements a preliminary report submitted on November 12, 1938, in compliance with Division Circular Letter, dated September 23, 1938, File N.A.D. 32/308.1. Additional wind, barometric, tidal, and wave data, for the coastal region of this District, from Chatham, Massachusetts, to Greenwich, Connecticut, have been assembled. The correlation of the various phases of the storm and its effects has been studied. The purpose of this report is to present a more complete discussion of the relation of causes and effects of the hurricane upon the coastal region. The effects upon structures and the nature of failures have been briefly considered

United States Engineer Office
Providence, Rhode Island
June 17, 1939

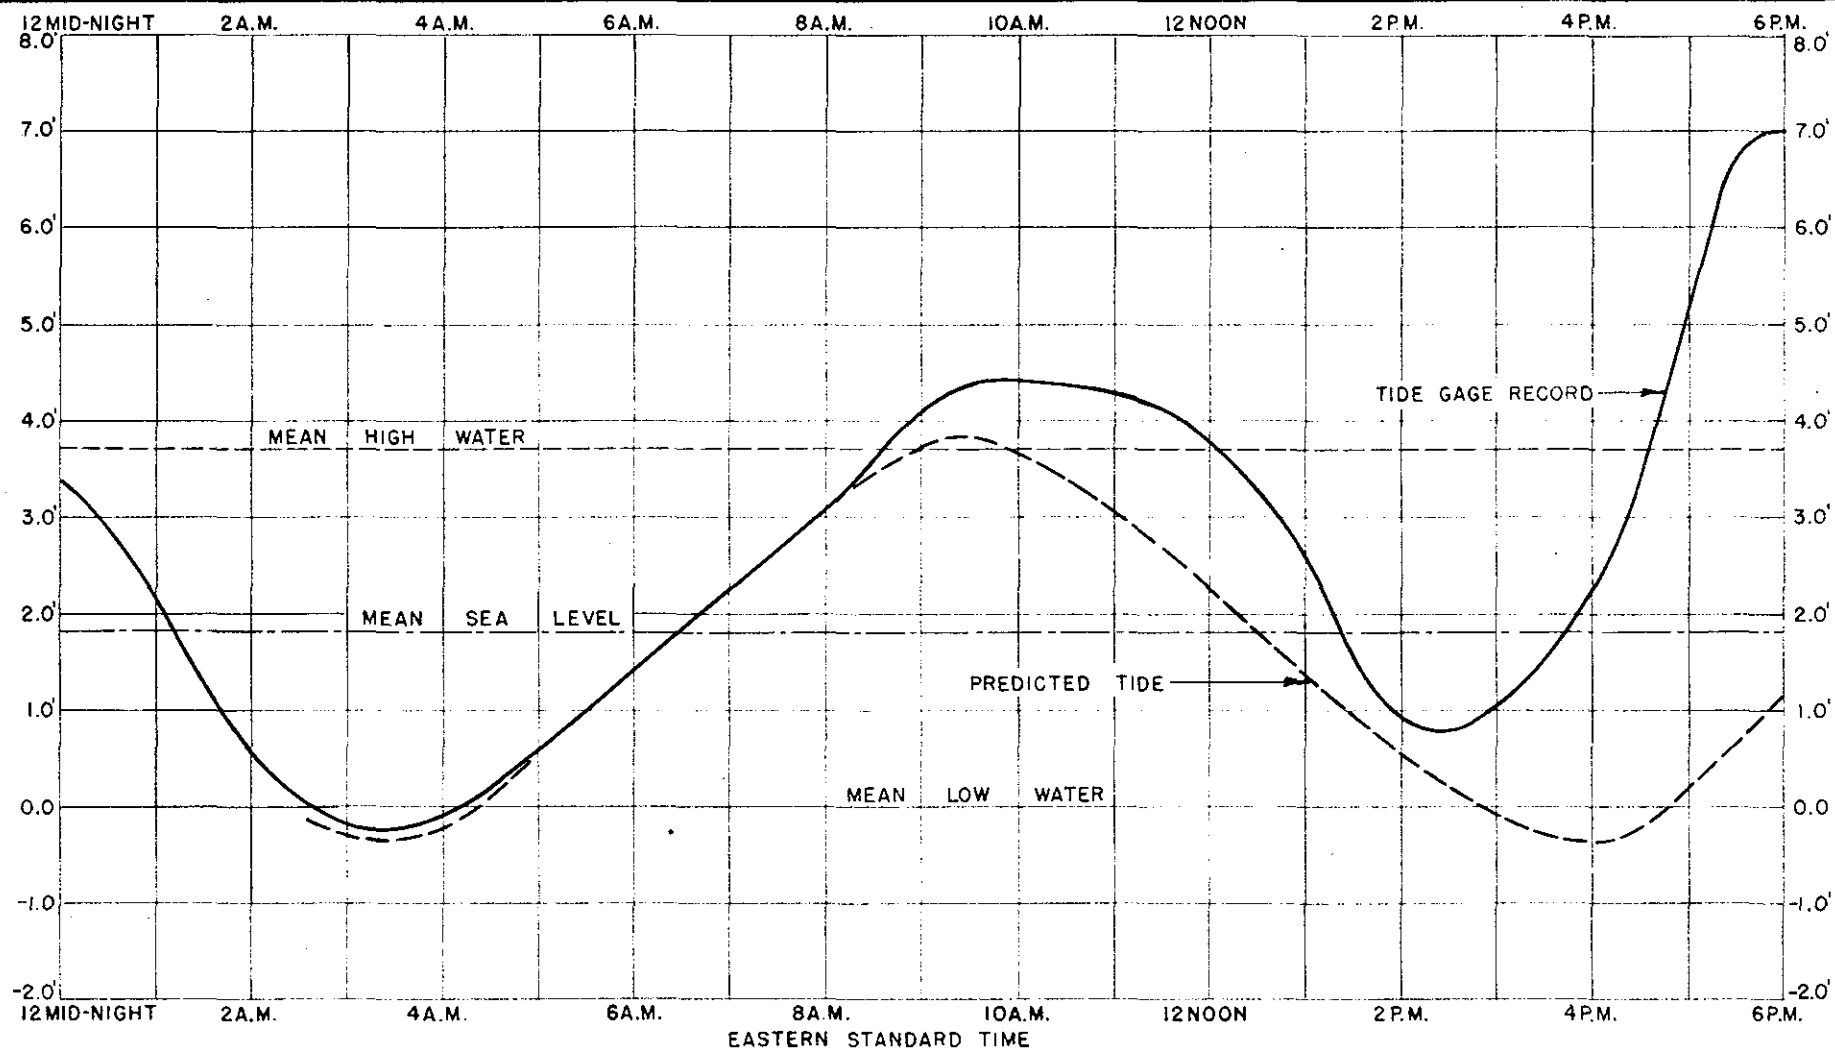
FIGURE 17

PROVIDENCE, R.I., DISTRICT
HARWICH, MASS.

TIDE CURVE

TIDE GAGE LOCATED AT WITCHMERE HARBOR

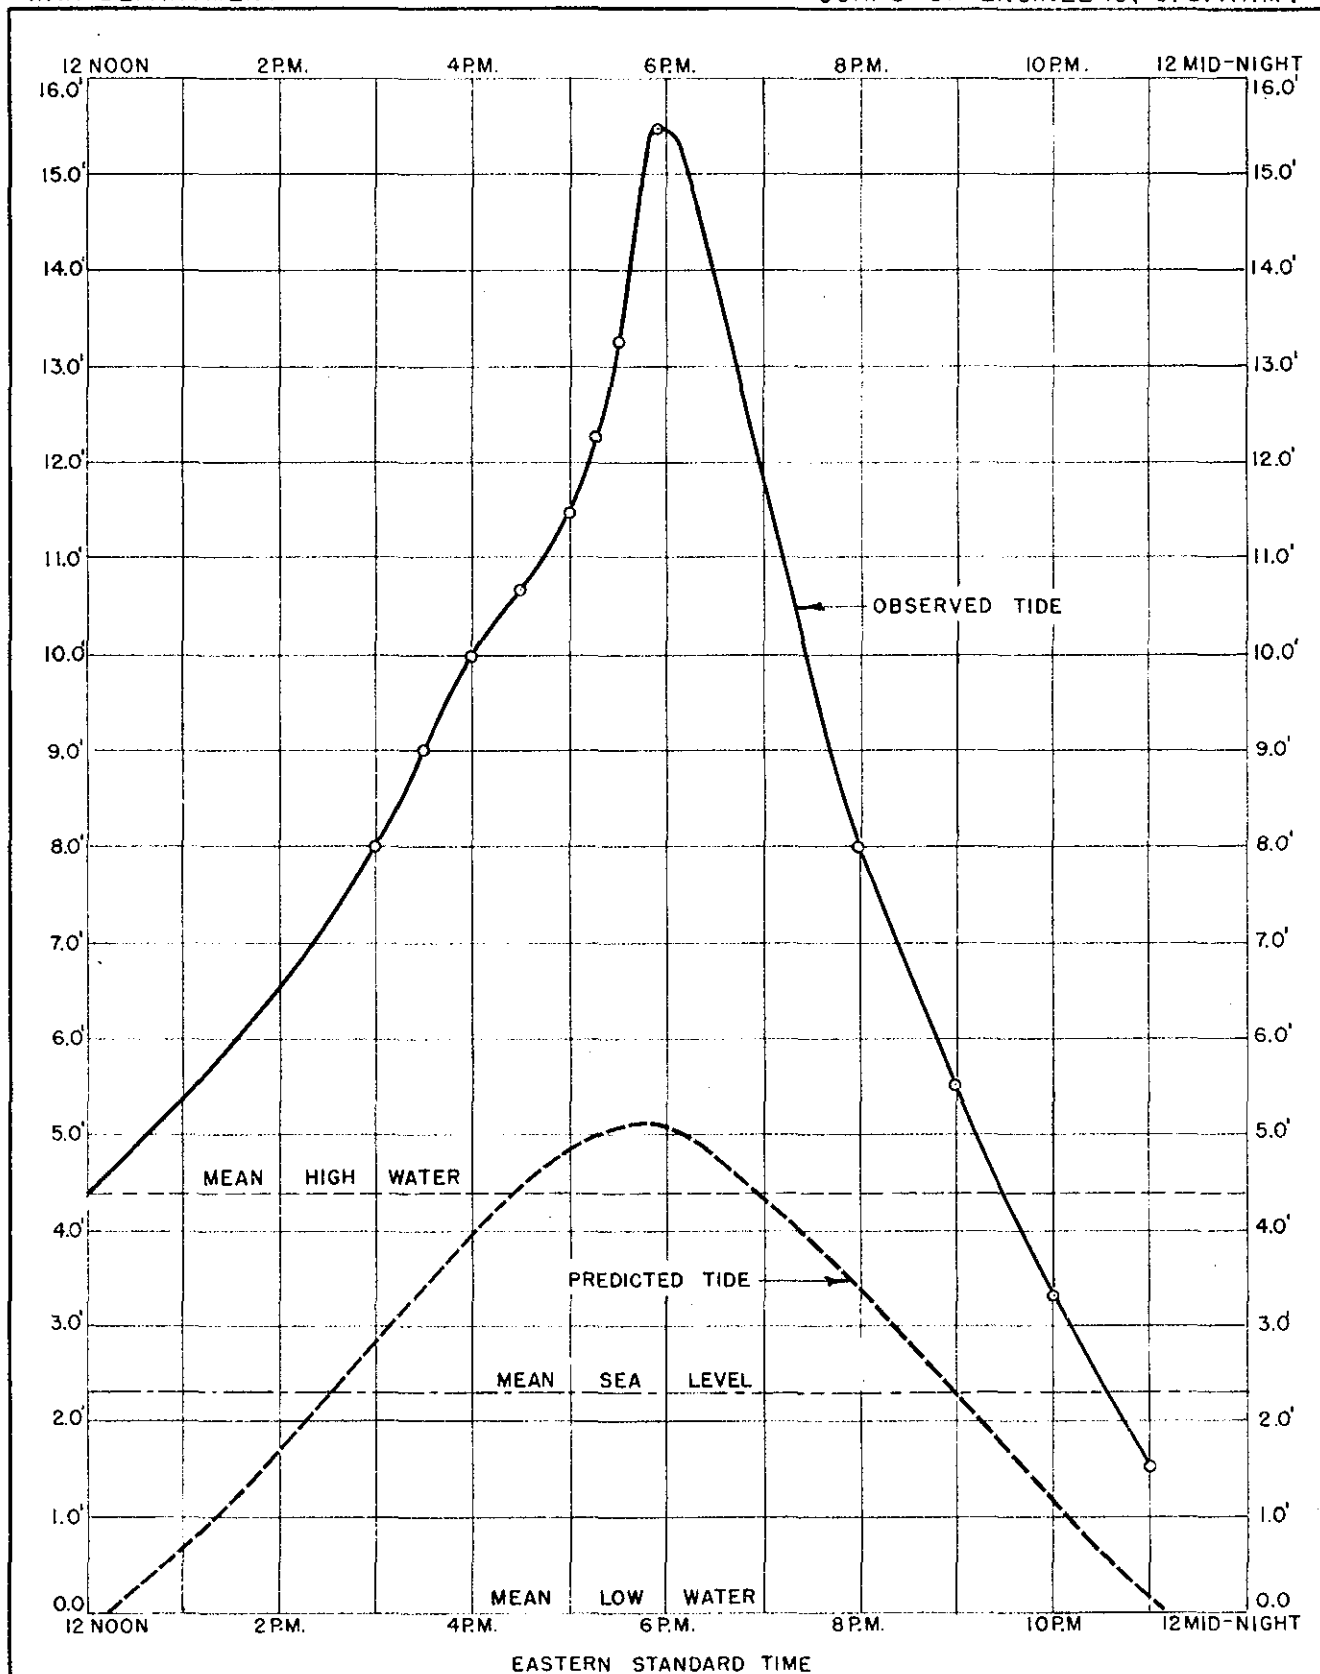
FIGURE 22

DATA FROM MONTAUP ELECTRIC CO.

SHOWN THUS ○

The propagation of high water of the combined waves into Narragansett Bay began about 5 p.m., E.S.T., or about 1/2 hour earlier than predicted for the gravitational tide. The relatively narrow passages east and west of Conanicut Island at the entrance probably retarded the surge. Time of high water at Newport (about 5:30 p.m., E.S.T.) coincided with predicted time (5:32) as nearly as can be determined. At Providence, at the head of the Bay, the same condition existed. Predicted time of high water for Providence was 5:52 p.m., and no deviation of time of actual tide could be determined. From Newport to Providence the speed of propagation apparently was similar to the normal speed of the gravitational tide. Tidal curves showing the peak of the rise at Newport and Providence were reconstructed from stages and times reported by various sources, and are included as Figures 20 and 21, respectively. The propagation of the surge in Sakonnet River and Mount Hope Bay was similar to that in Narragansett Bay. High water at Fall River occurred about at its predicted time, 5:47 p.m., E.S.T. At Somerset, Massachusetts, on Taunton River, opposite Fall River, the Montaup Electric Company furnished observed heights which are shown on Figure 22. High water was reported at 5:52 p.m. or at about the predicted time.

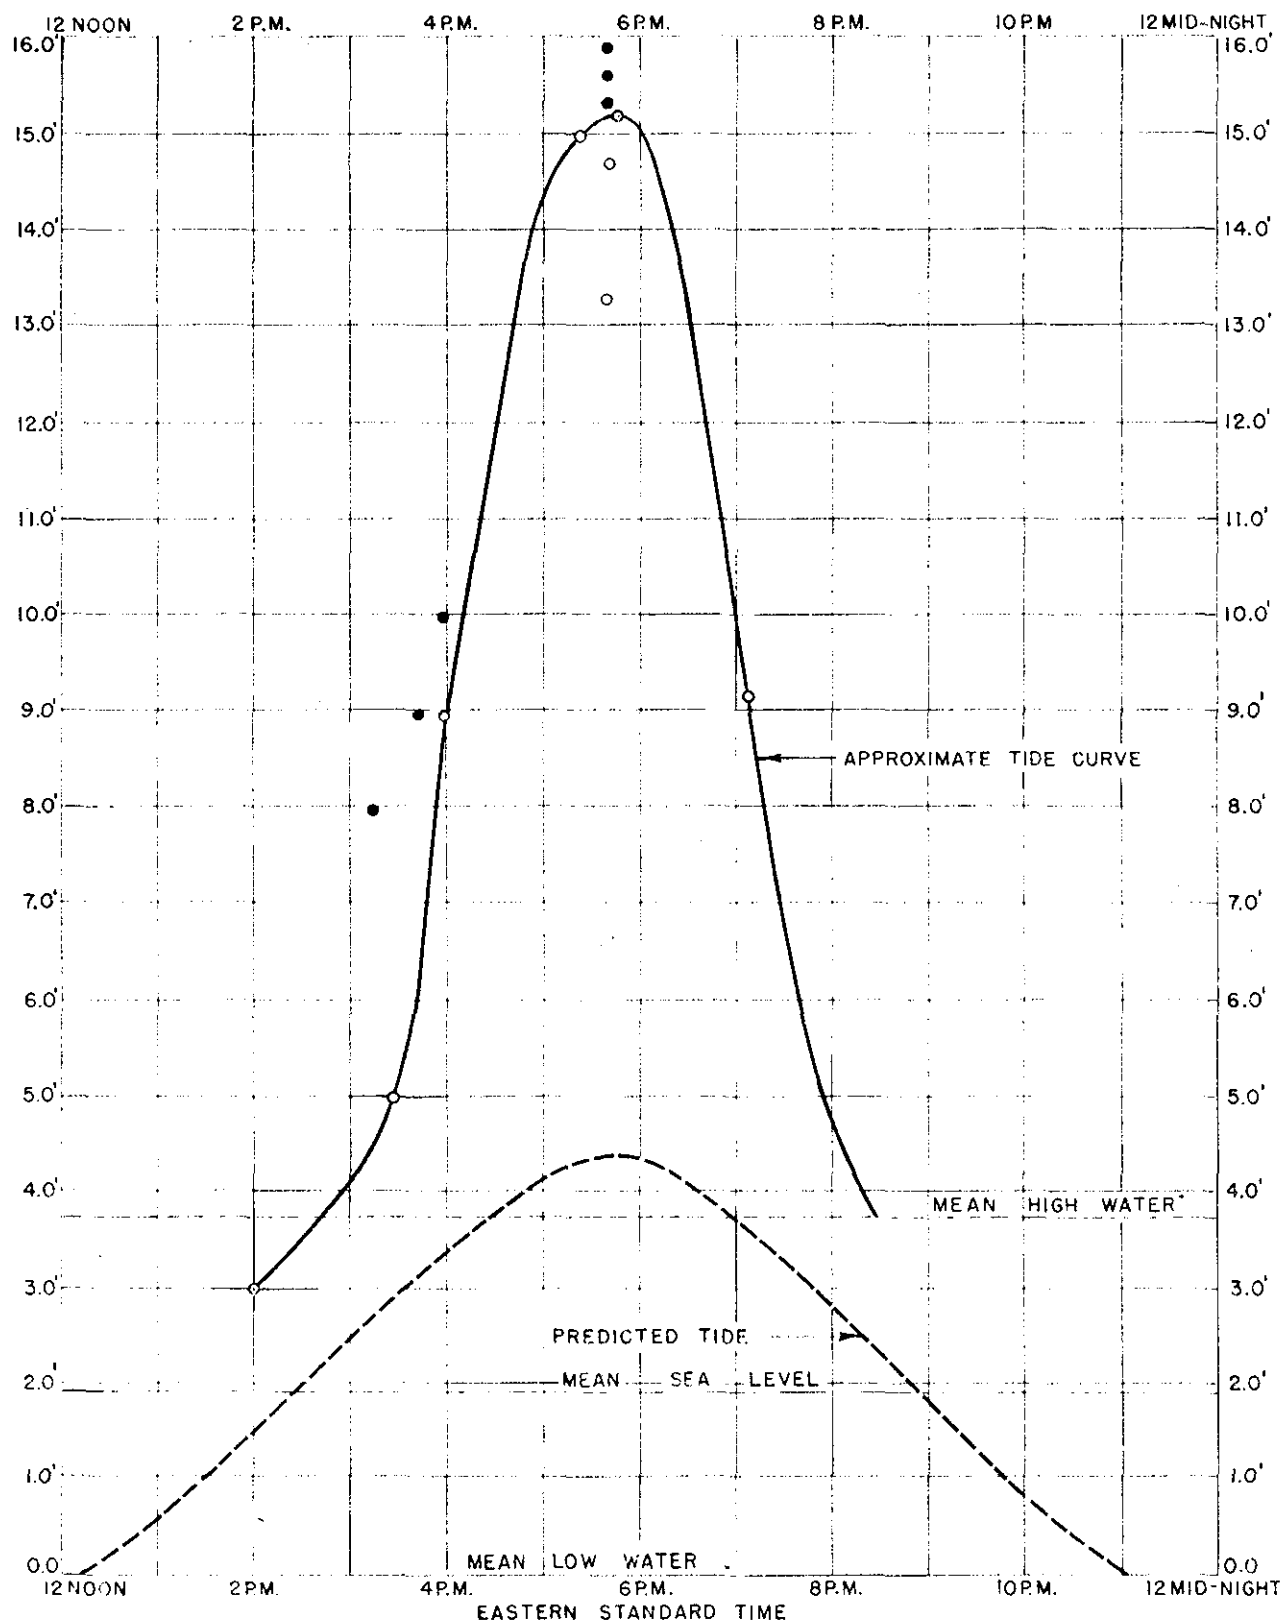
REPORTED HEIGHTS IN SHELTERED LOCATIONS
SHOWN THUS: ○
REPORTED HEIGHTS IN EXPOSED LOCATIONS
SHOWN THUS: ●

PROVIDENCE, R.I., DISTRICT
NEW BEDFORD, MASS.
TIDE CURVE

SEPTEMBER 21, 1938
U.S. ENGINEER OFFICE, PROVIDENCE, R.I.
APRIL 28, 1939 FILE NO. R&H.M. 287-8

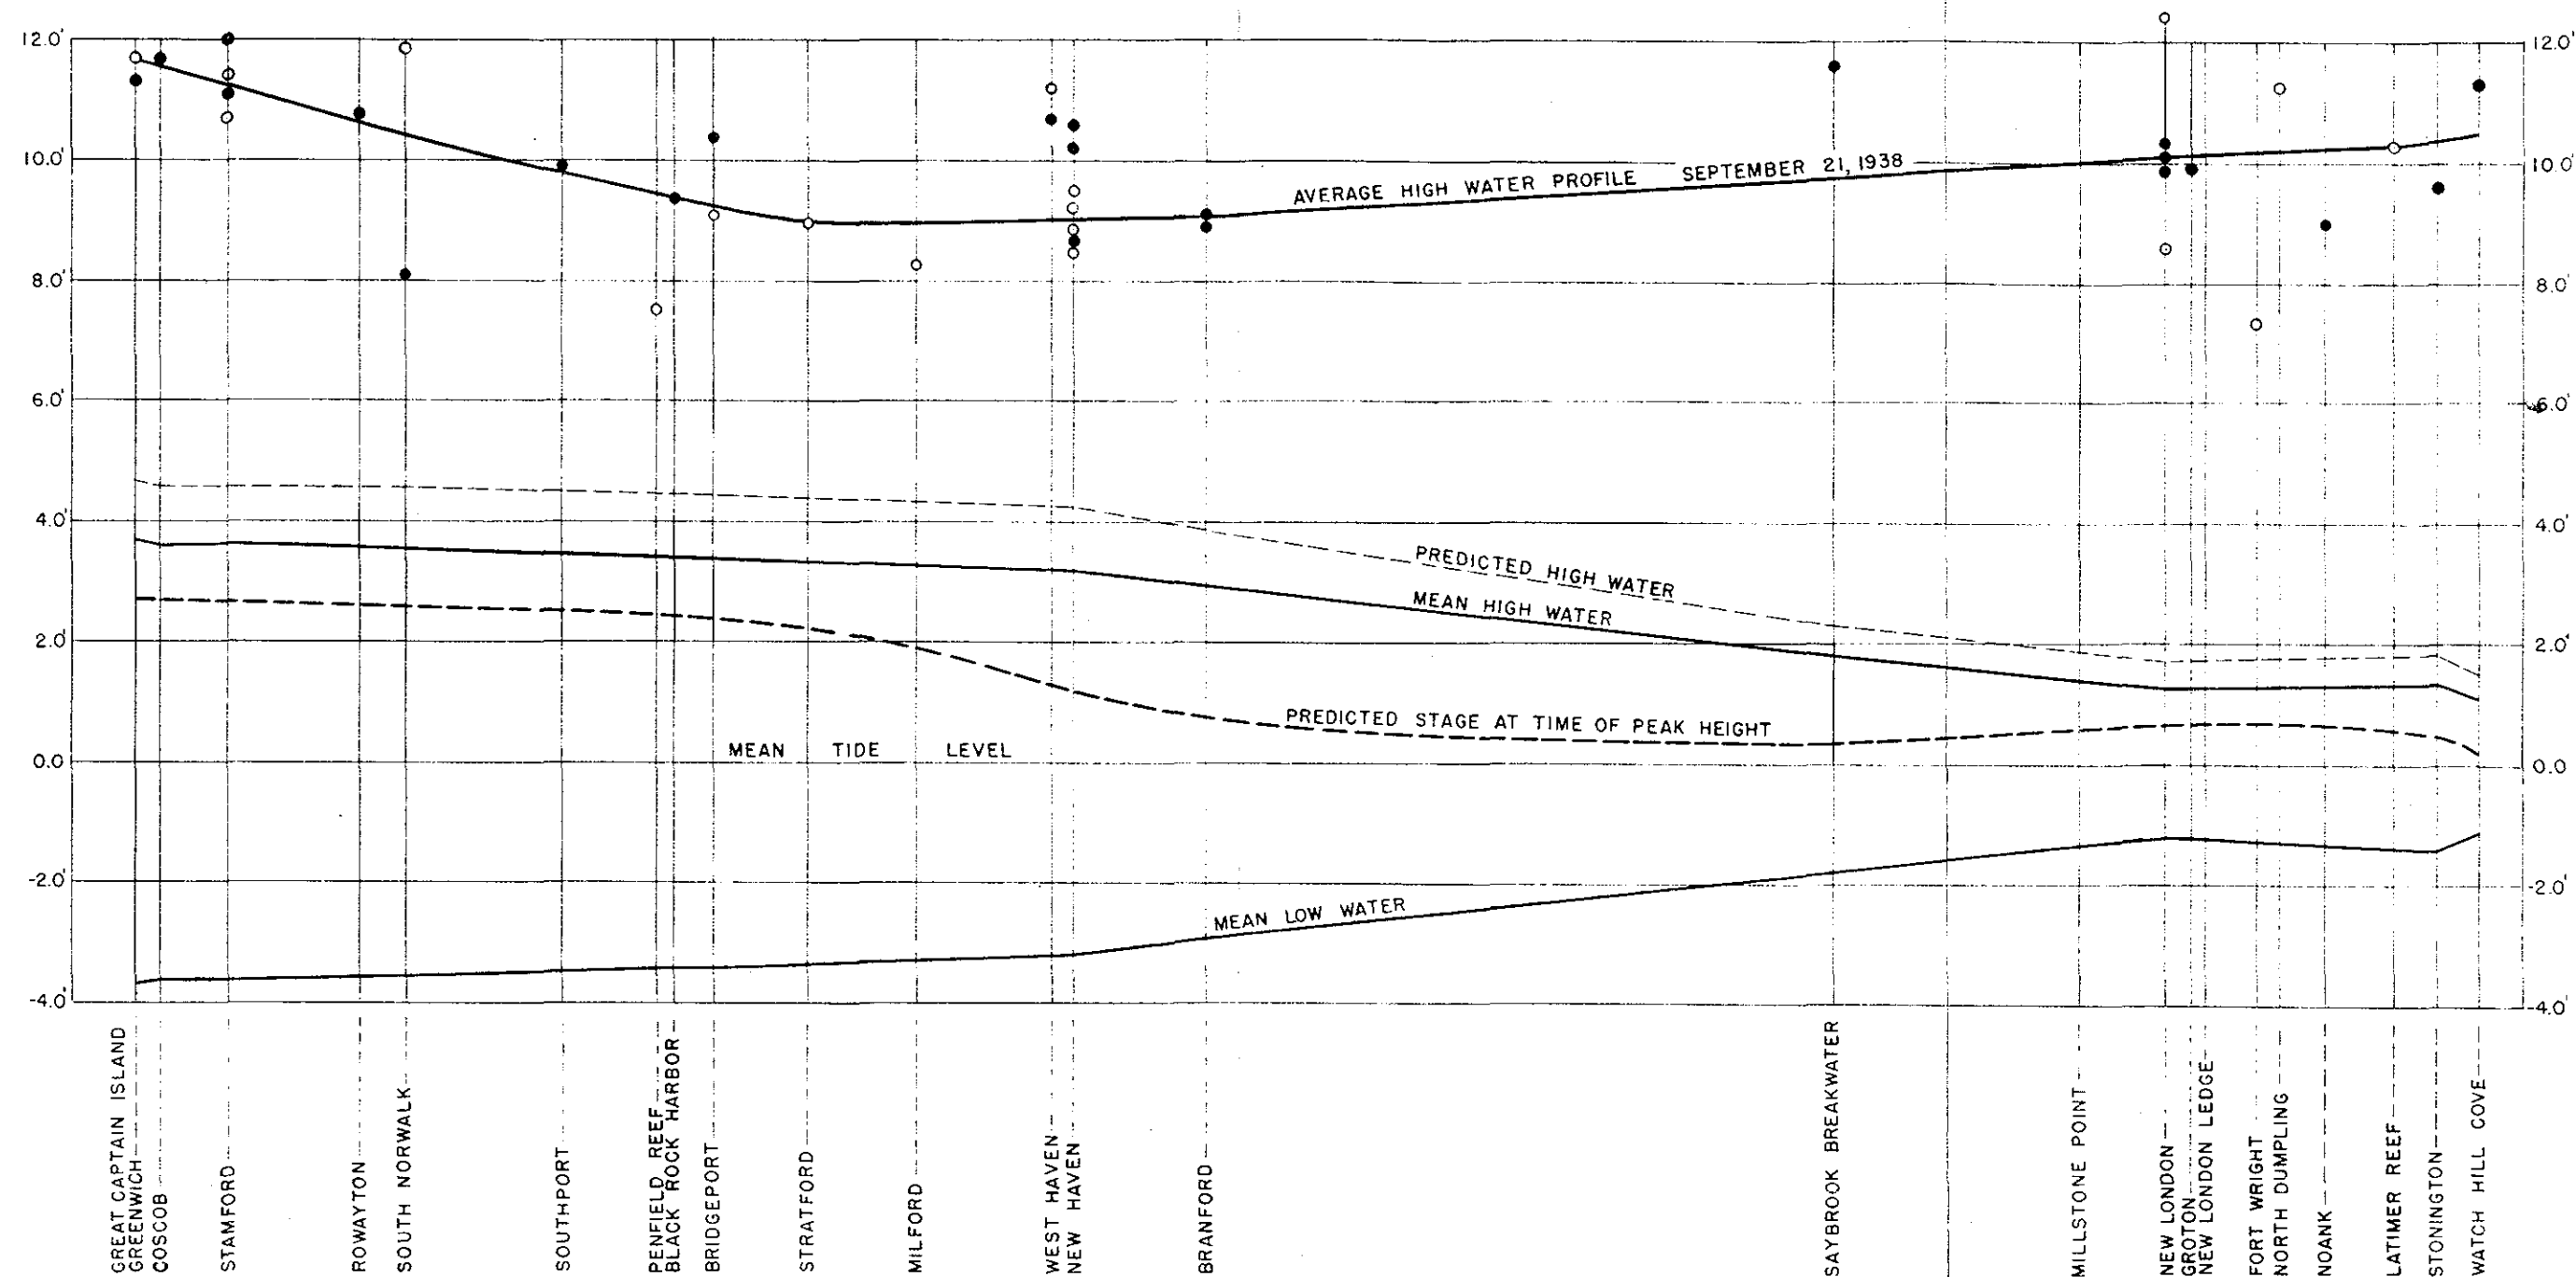
PROVIDENCE, R.I., DISTRICT
 LONG ISLAND SOUND
 HIGH WATER PROFILE
 SEPTEMBER 21, 1938
 U.S. ENGINEER OFFICE, PROVIDENCE, R.I.
 MAY 25, 1939 FILE NO. R.&H.M. 289-2

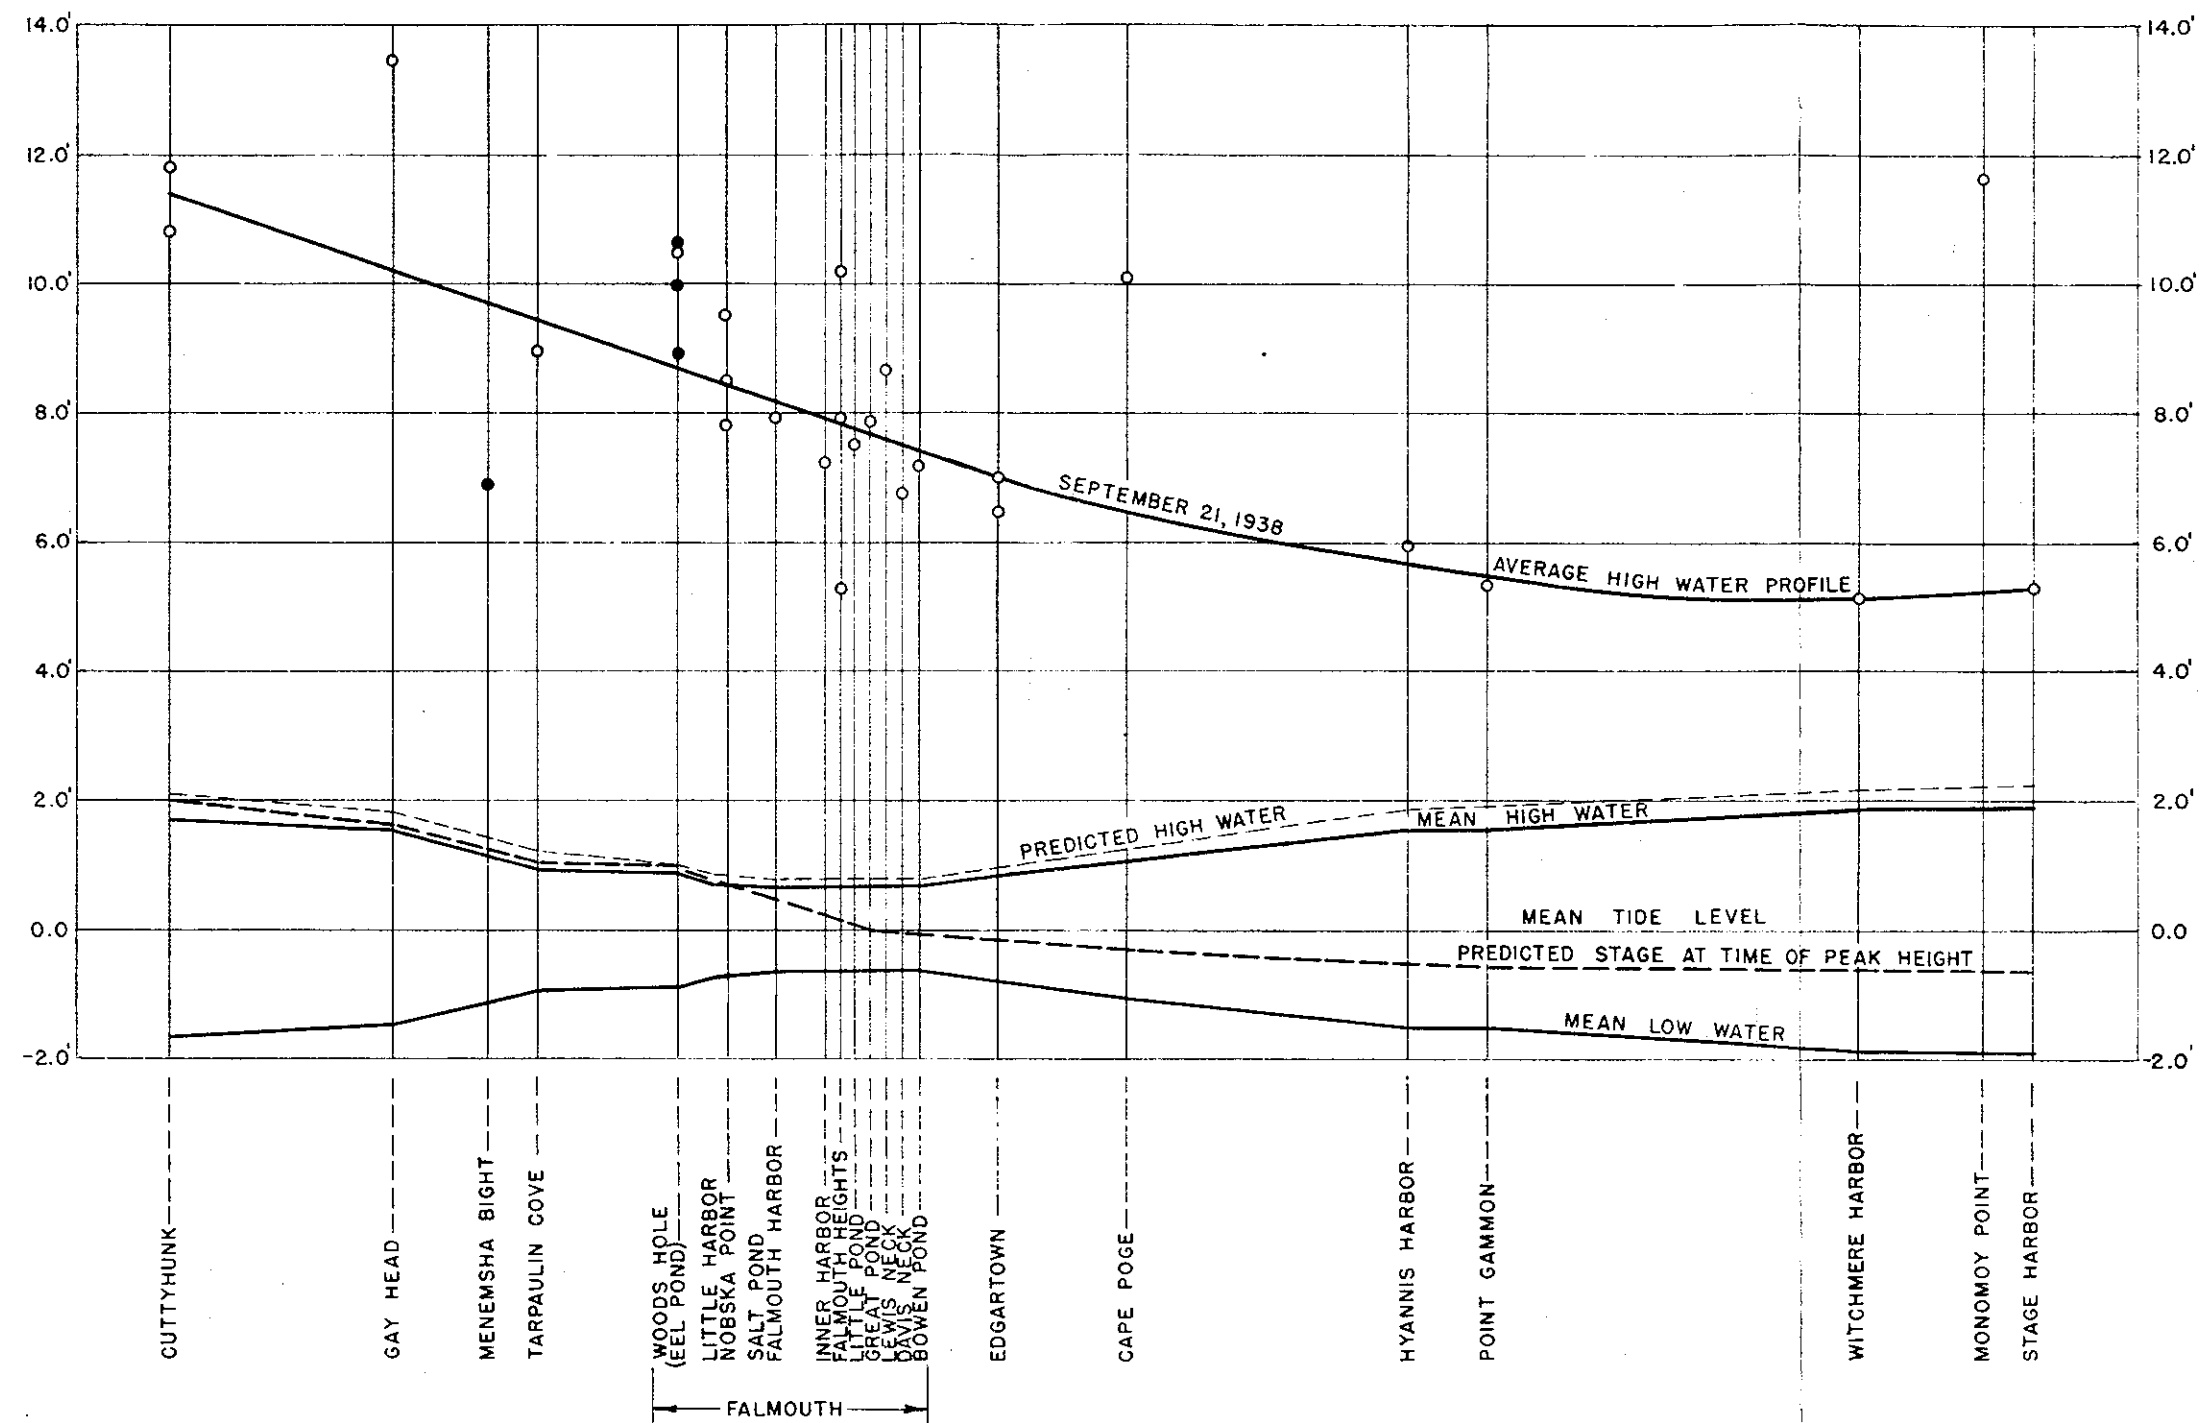
DATA BY U.S.E.D. SHOWN THUS: ●
DATA FROM OTHER SOURCES SHOWN THUS: ○

PROVIDENCE, R.I., DISTRICT
VINEYARD & NANTUCKET SOUNDS
HIGH WATER PROFILE
SEPTEMBER 21, 1938
U.S. ENGINEER OFFICE, PROVIDENCE, R.I.
MAY 25, 1939 FILE NO. R&H.M.289-4

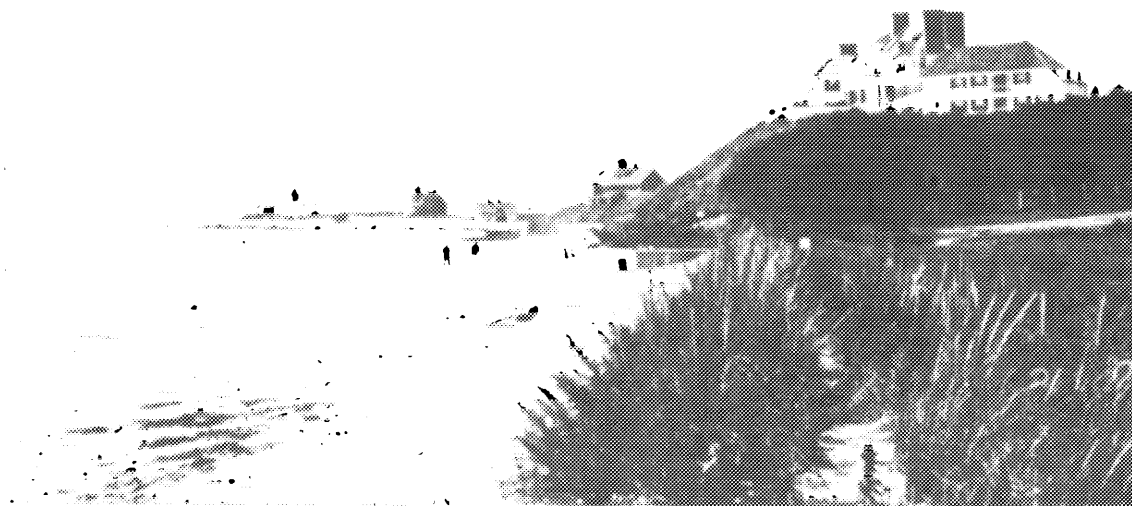
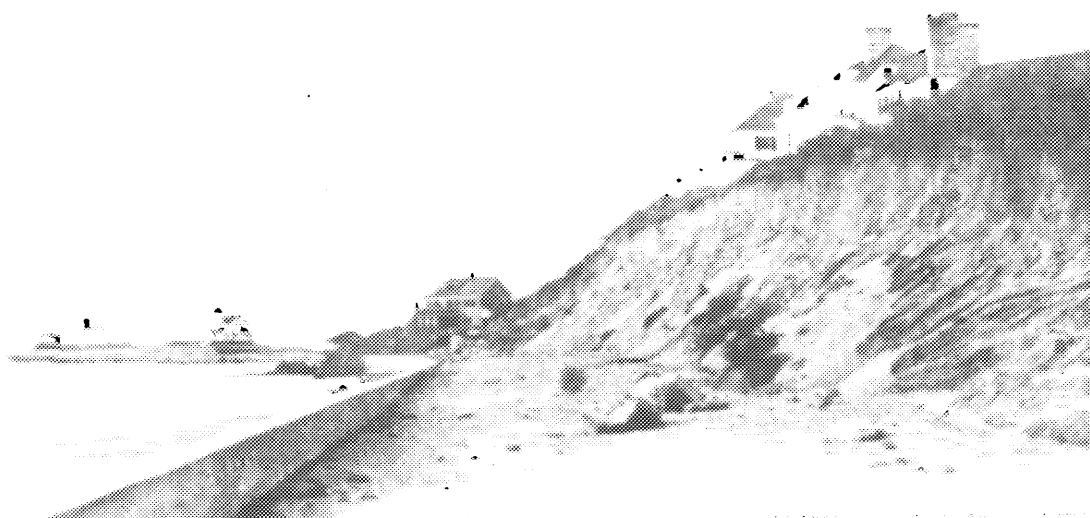
BEFORE HURRICANE

AFTER HURRICANE

WATCH HILL, WESTERLY, R. I.
Waves eroded headland behind seawall and the splash
floated furniture in house at top of hill.

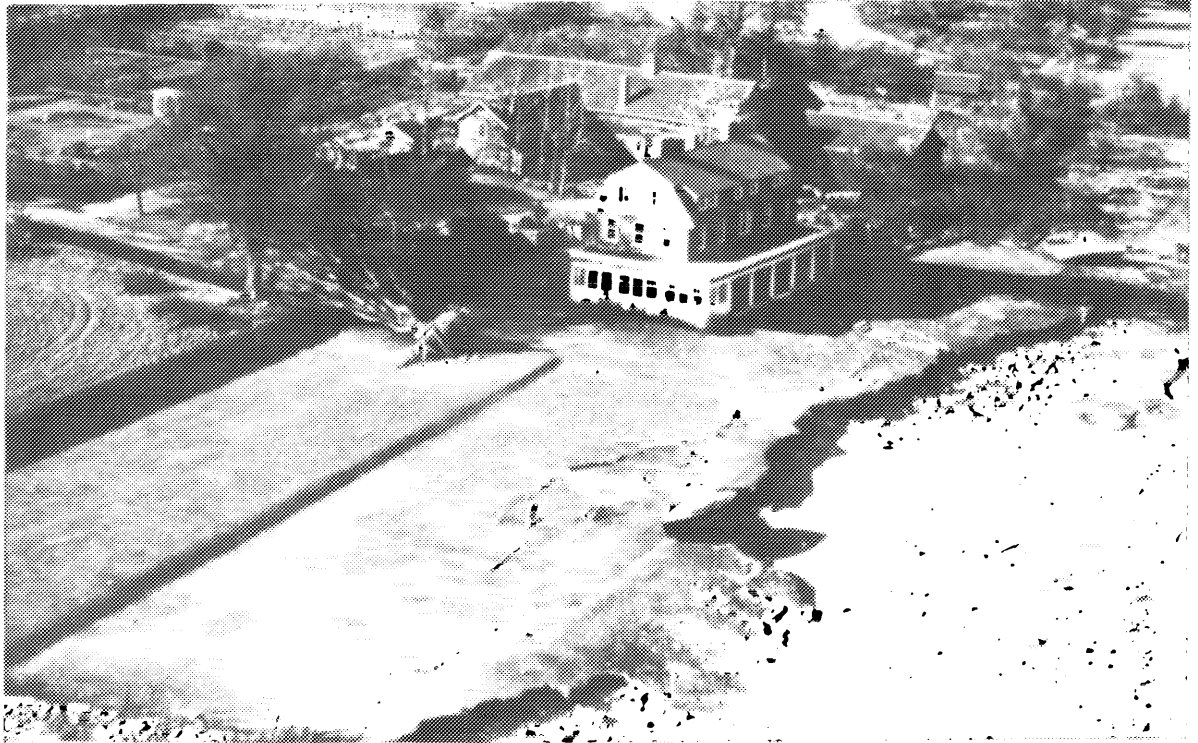
WARWICK NECK, R. I.
Trees damaged; upland eroded; boats stranded.

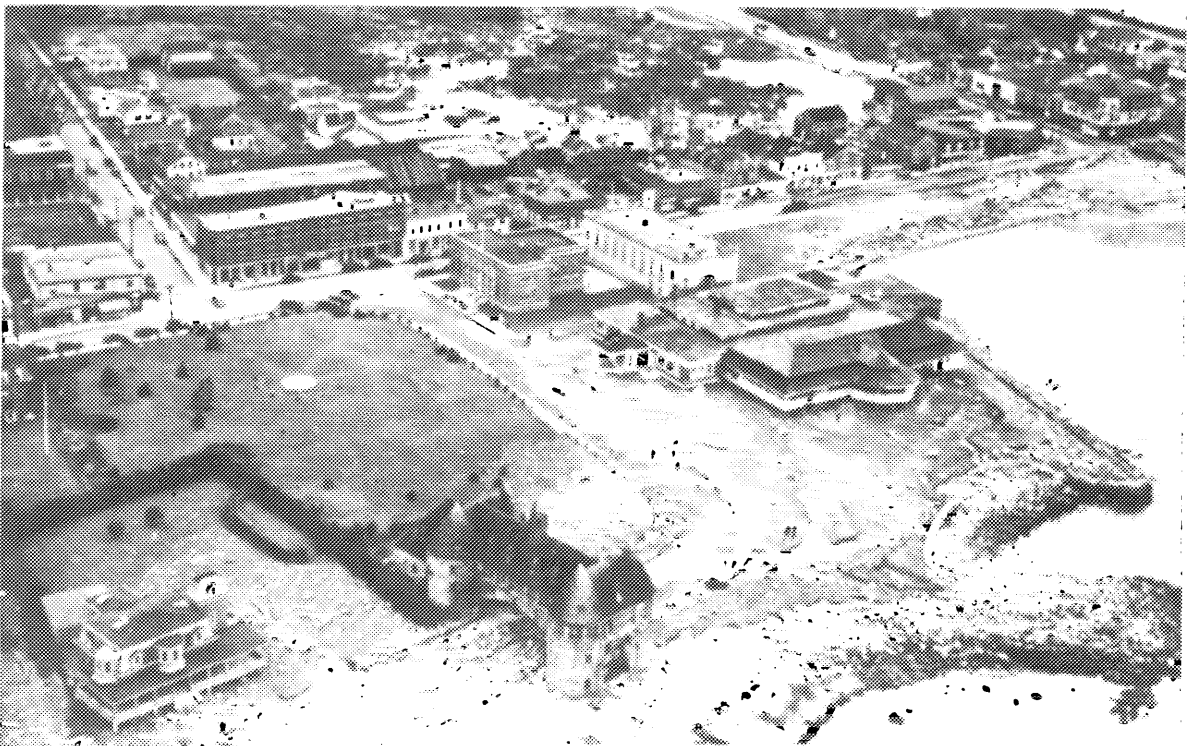
NARRAGANSETT PIER, R. I.
Headland erosion and wash-out of Ocean Drive.

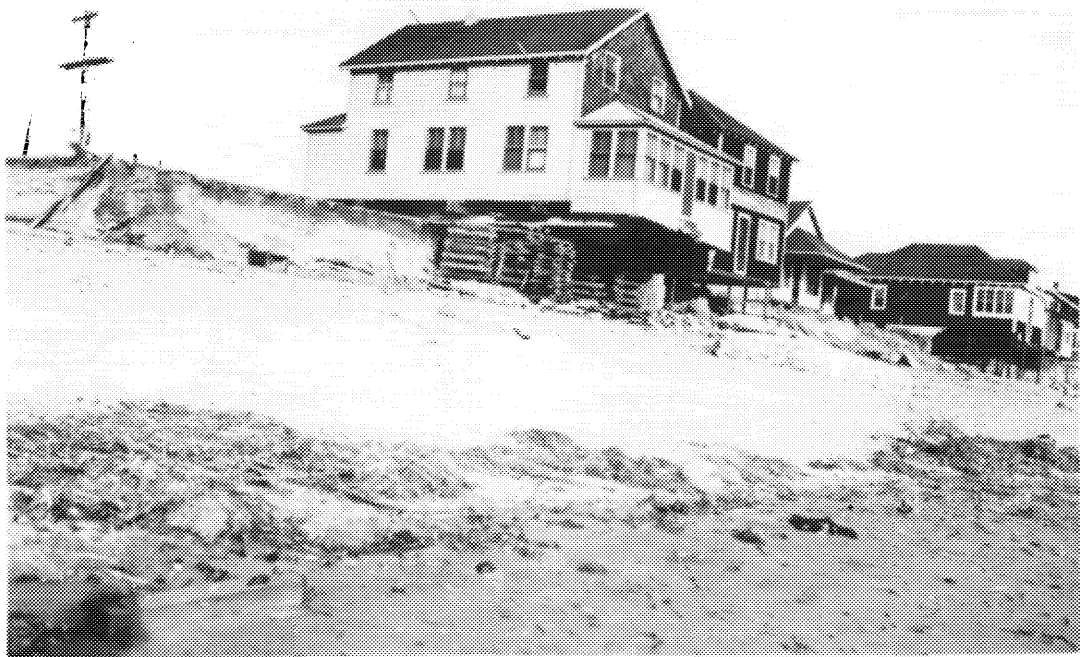
OCEAN GROVE, SWANSEA, MASS. Headland erosion under house. Seawall destruction.

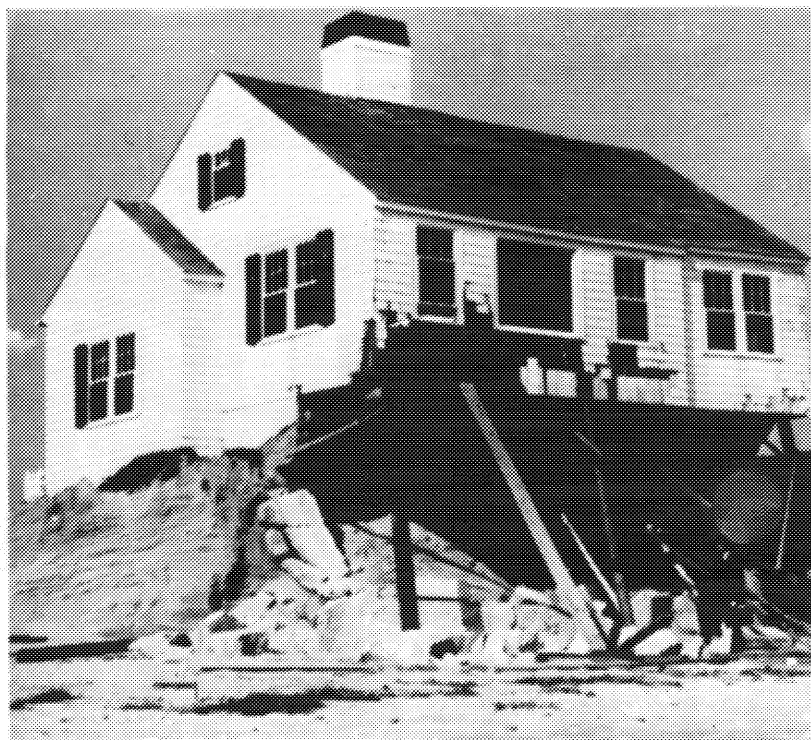
BONNET SHORES, NARRAGANSETT, R. I.
Erosion of sand dune under house.

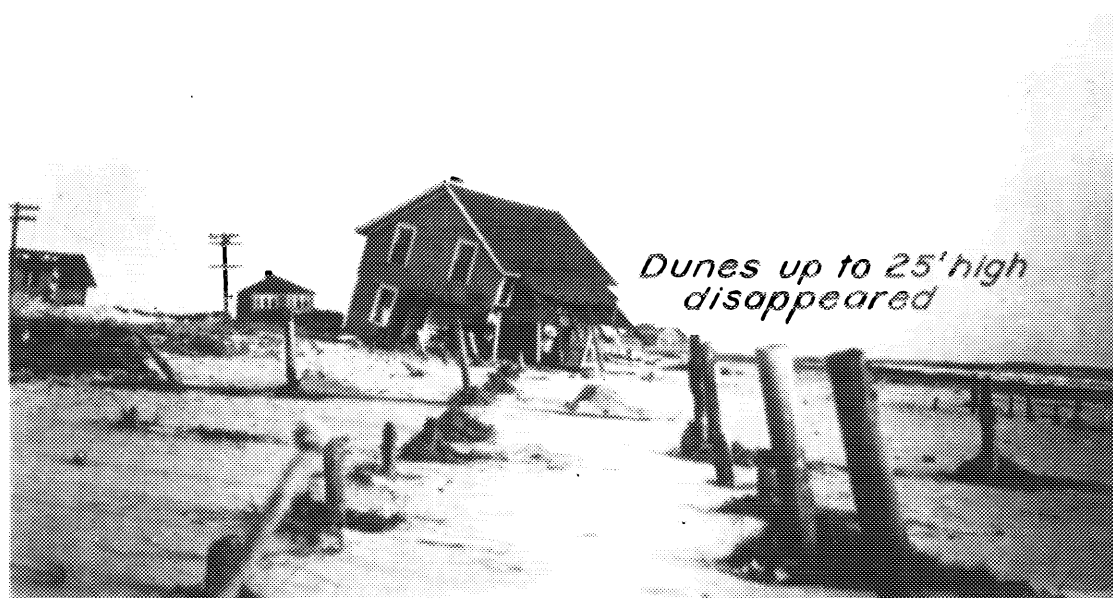
*Dunes up to 25' high
disappeared*

HORSE NECK BEACH, WESTPORT, MASS.
Sand dunes washed away.

strongly framed building on a substantial foundation (Plate 18), was entirely cleaned out, leaving only the walls. Less strongly built and well founded structures did not survive this attack. Dunes up to 25 feet in height disappeared as the waves broke over them. (See Plate 6). Some low seawalls, such as that at Watch Hill shown on Plate 2, survived because they were completely submerged and protected from the most violent attack. Waves striking vertical surfaces were thrown to great heights. Instances where debris was thrown high causing damage to light towers and buildings are cited in the foregoing table. Seaweed and shellfish were found in upper stories of buildings up to 50 feet above low water. The effect of wave action at Watch Hill in Westerly, Rhode Island, is of particular interest. The large residence shown on Plate 2 is located at the top of a steep bluff at an elevation of about sixty-five feet, and seventy feet in back of a seawall about 10 feet above mean low water. Persons in the house at the time state that solid sheets of water struck the house with great violence. Windows and doors were broken, and water entered the house sufficient to float large pieces of furniture. After the storm subsided, sand, small stones and seaweed were about one foot deep on the main floor of the house.

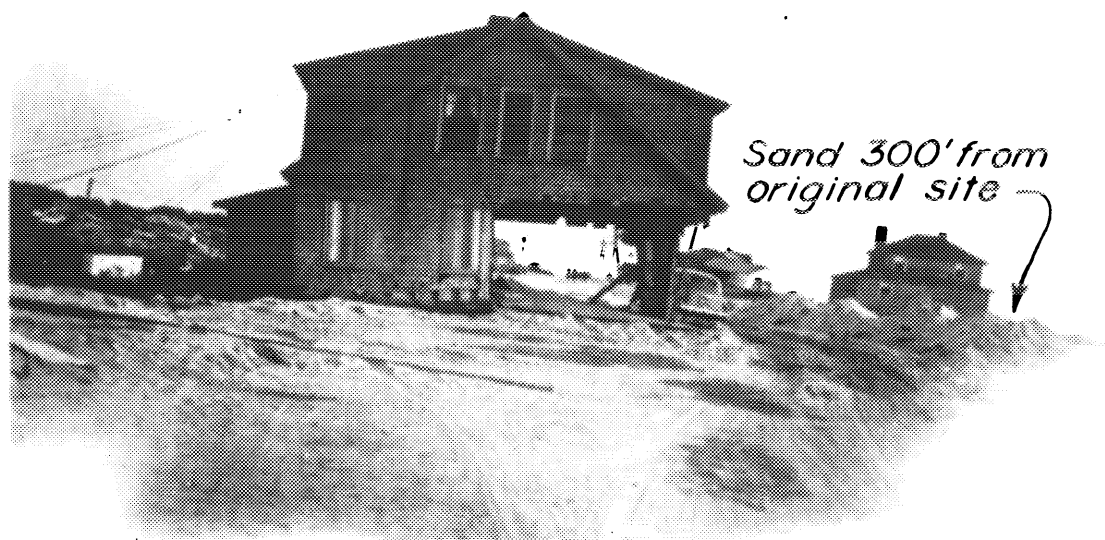
*Sand 300' from
original site*

HORSE NECK BEACH, WESTPORT, MASS.
Sand deposited 300' from former location.

as illustrated by Plate 6, and erosion of the second row occurred. Horse Neck Point at the western end of the beach was washed over for a length of about one-quarter mile and the dunes were levelled. The foreshore suffered little if any change, except at the Point. Here a jetty had caused accretion amounting to several hundred feet. The hurricane wave cut behind the jetty and moved the high water line approximately to its former location, and extended the Point somewhat to the westward.

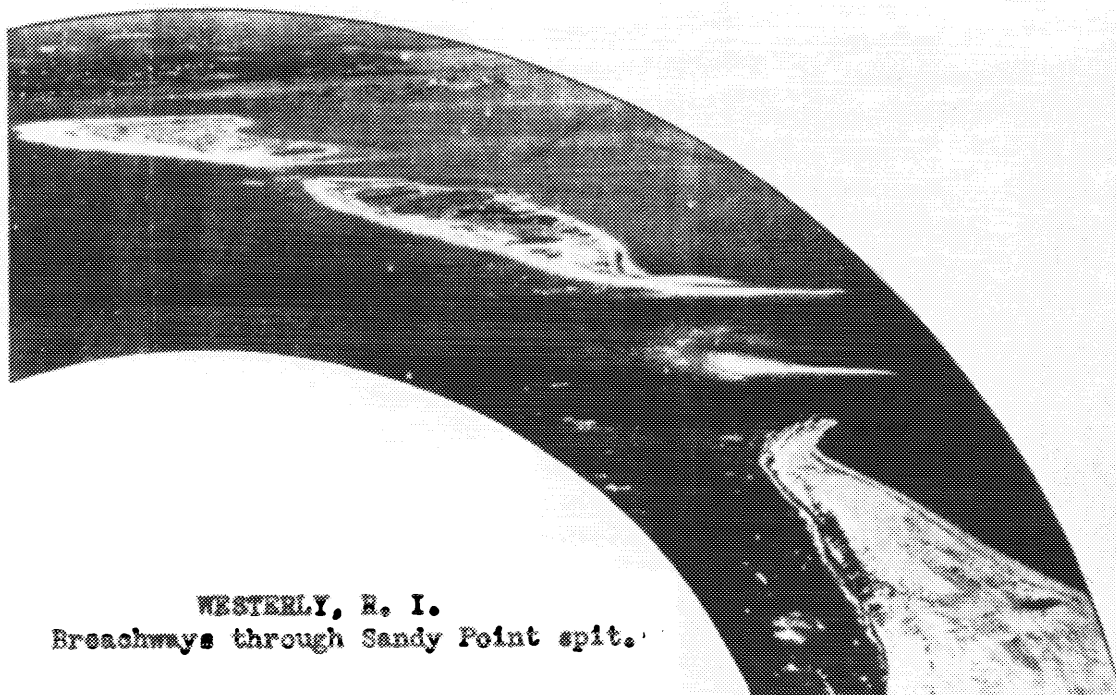
WESTERLY, R. I.
Breachways through Sandy Point spit.

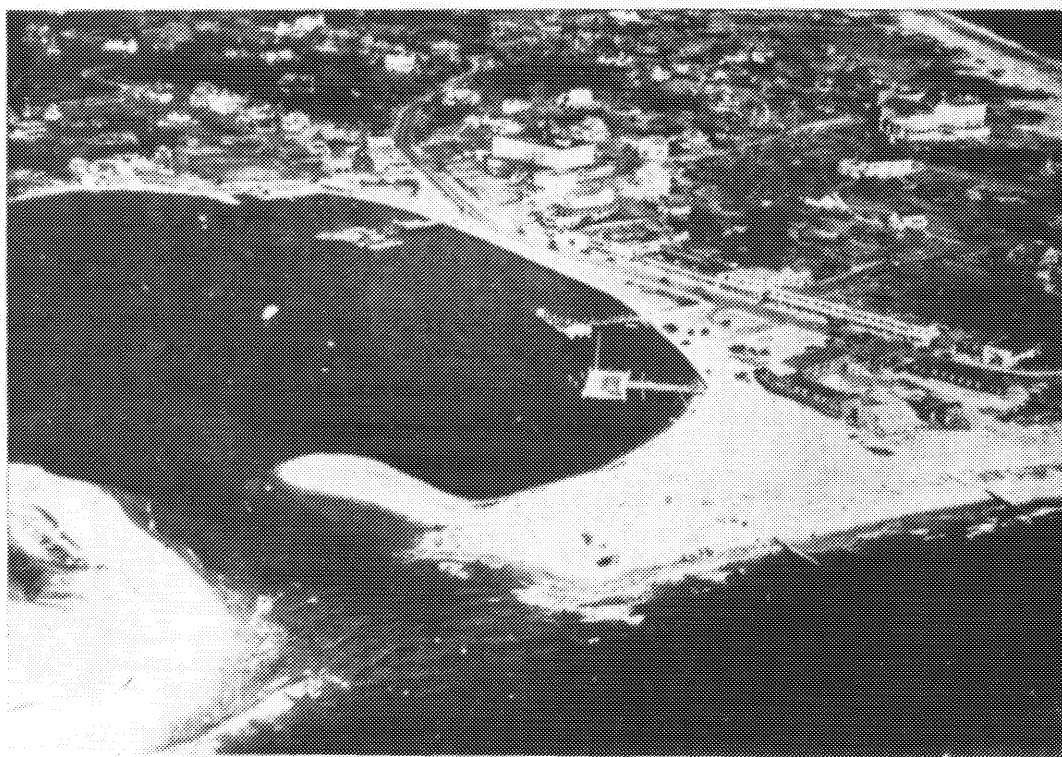
WESTERLY, R. I.
Breachway into Watch Hill Cove through Napatree Point tombolo.

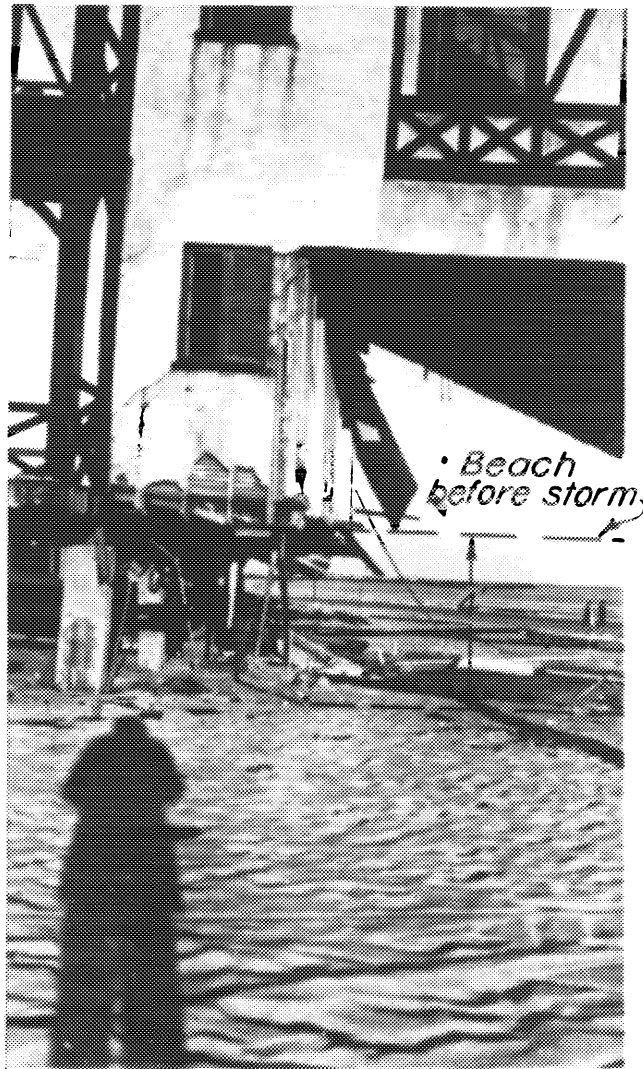
NARRAGANSETT PIER, R. I.
Beach at Dunes Club
eroded 3' to 4' seaward
of buildings.

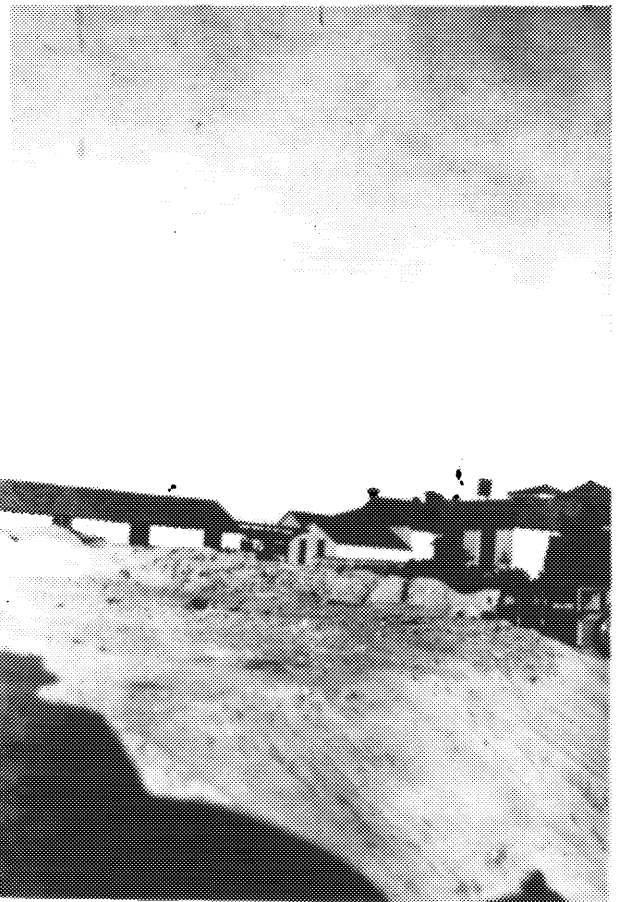
NARRAGANSETT PIER, R. I.
3' to 4' sand deposited
landward of buildings
at Dunes Club.

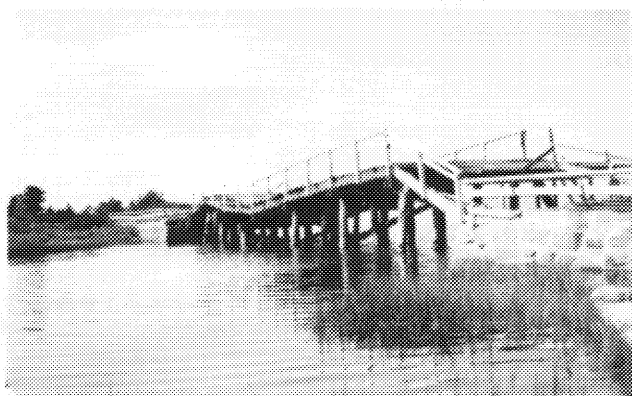
WEST PALMOUTH, MASS.
Highway bridge damage.
